Concrete Supply Company - Lincolnton Plant

831 Madison St  
Lincolnton, NC 28092

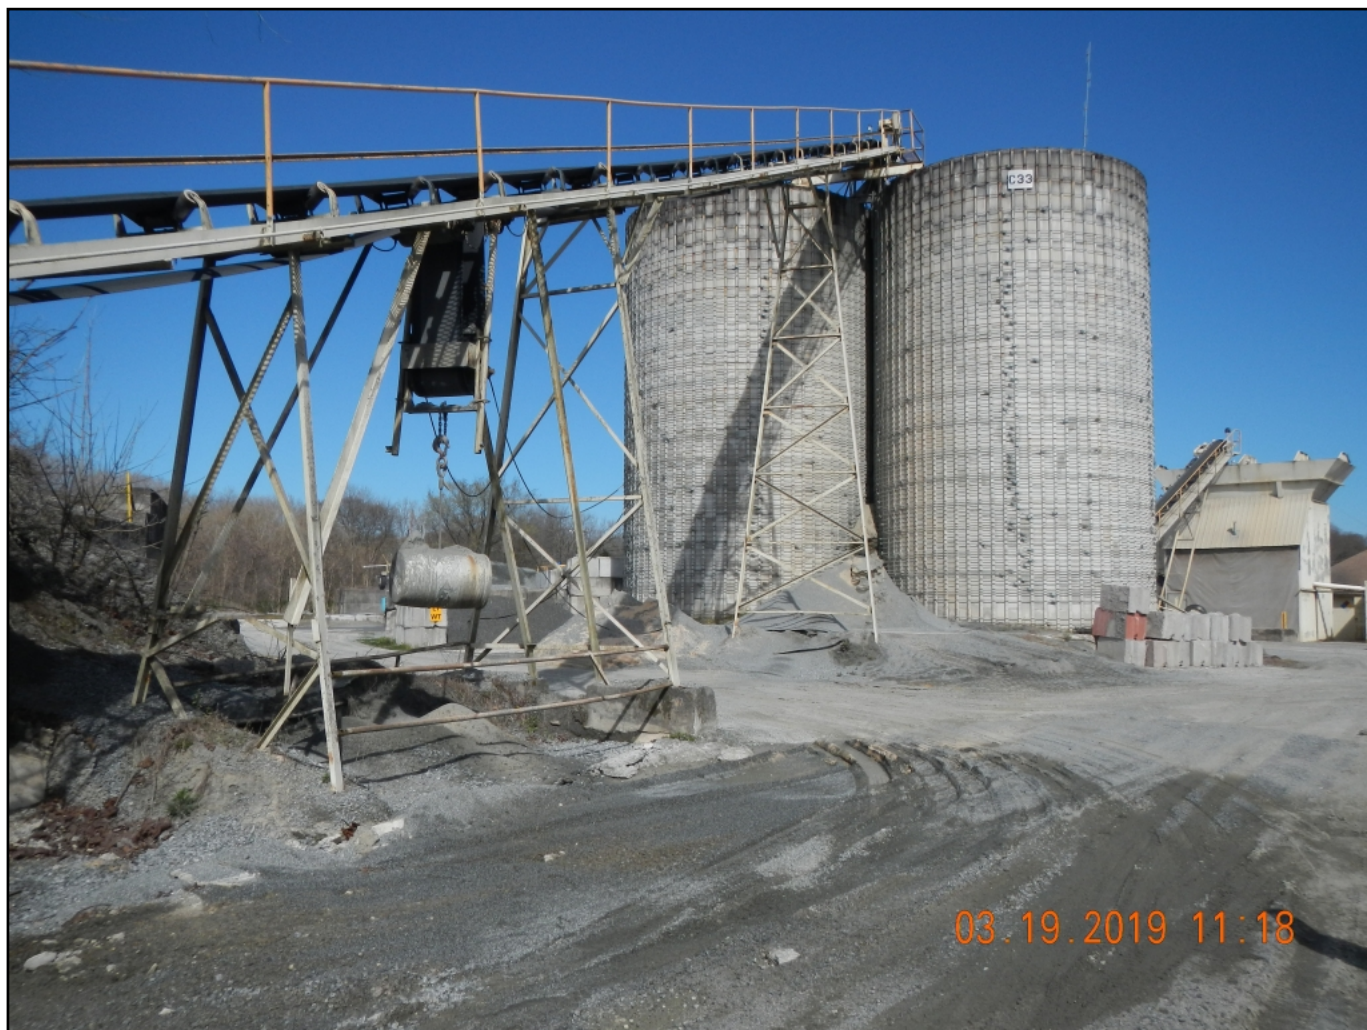
| File Name | DSCN1858.JPG |

| Description | Photograph of the loading hopper to the storage silos. The loading hopper was located near the crest of a hill leading to the stream. Sediment accumulation was observed along the ground in this area which drains towards the stream. |

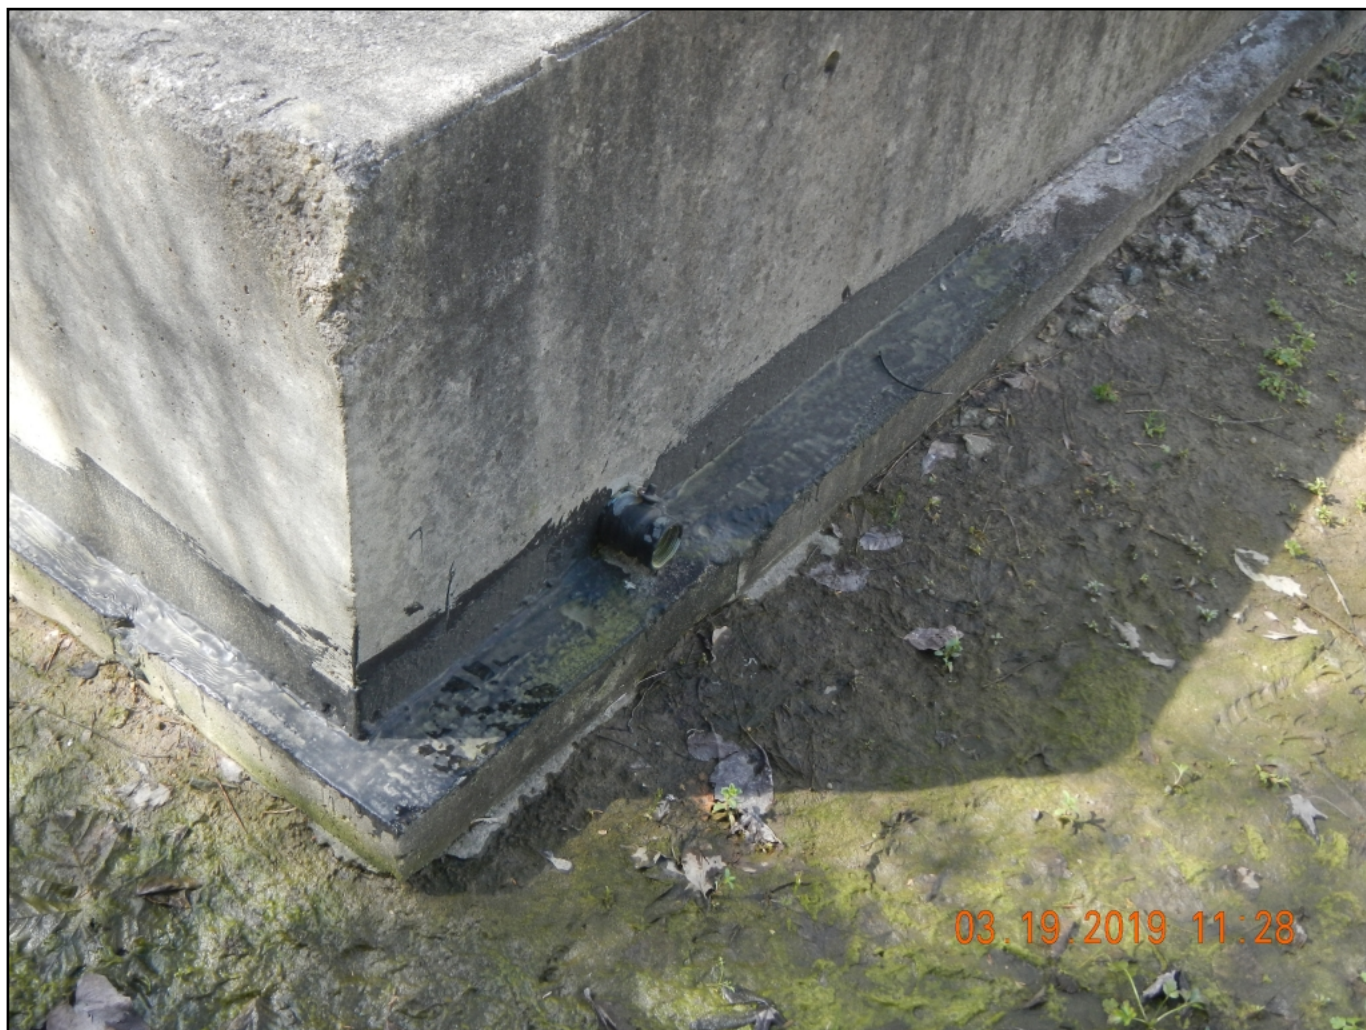
| File Name | DSCN1861.JPG |

| Description | Photograph of the outdoor chemical storage area and tanks. The tank area had a secondary containment structure with a release valve. The valve, which was observed with the valve handle removed, was observed closed during the inspection. |

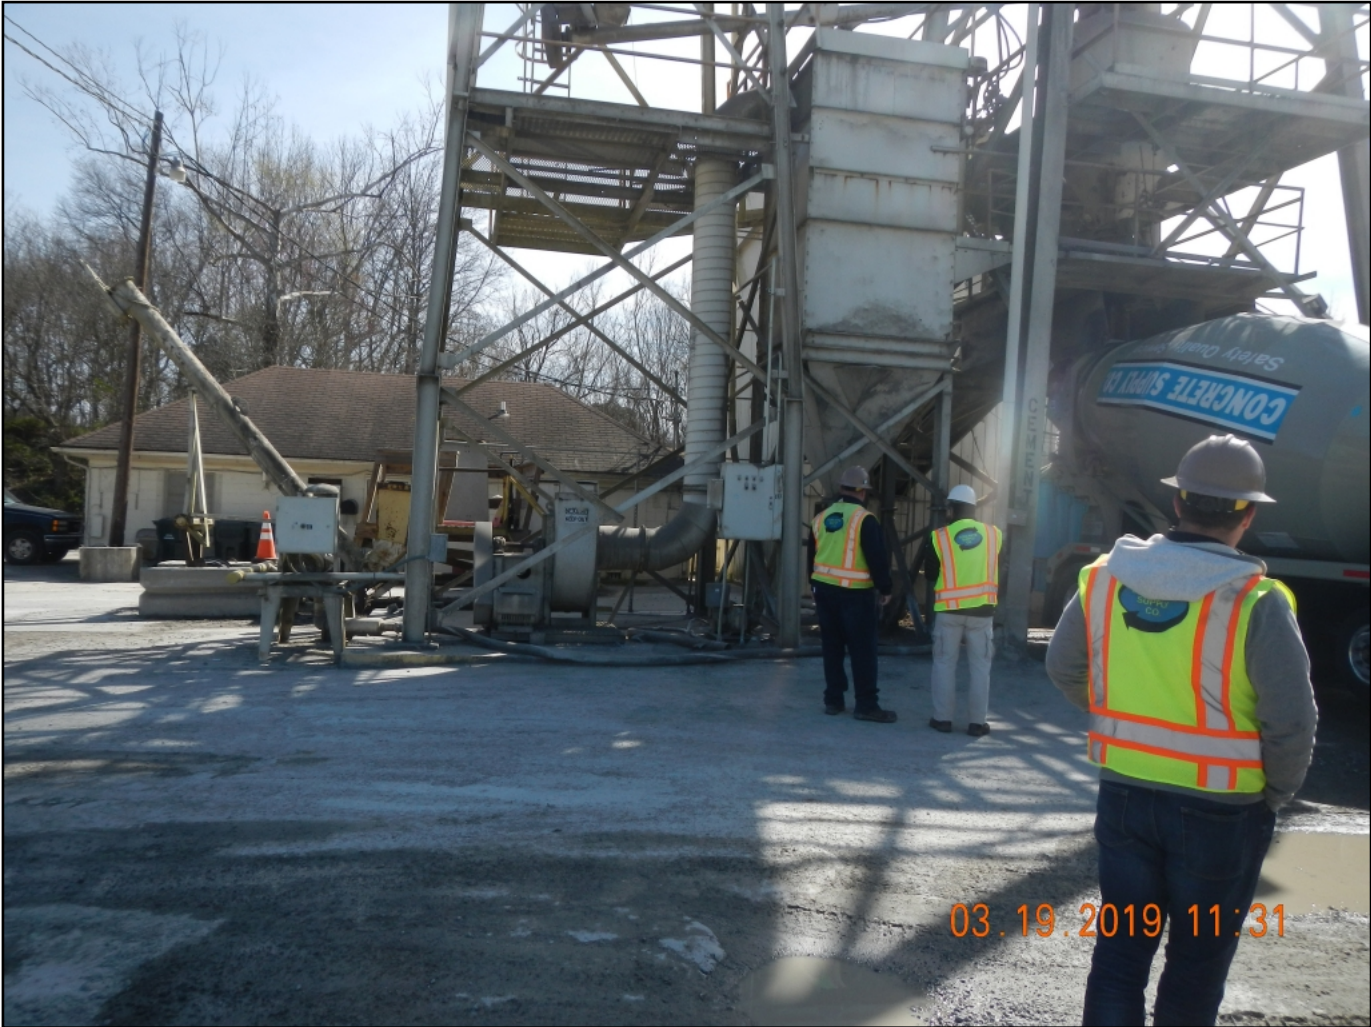
| File Name | DSCN1863.JPG |

| Description | Photograph of the truck loading operation. |
